RESIDENTIAL REPORT

1527 Mockingbird Dr
Naples FL 34120

AUGUST 31, 2021

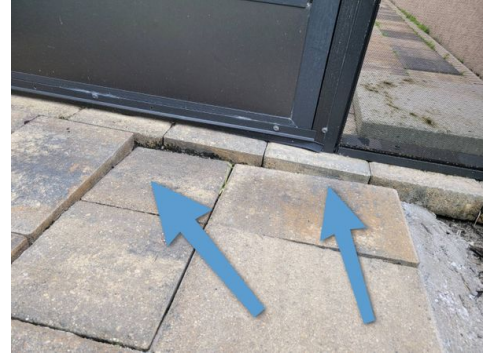
2.3.1 Lanai

LANAI PAVERS- SETTLEMENT

There were some settling pavers observed in the lanai area. I recommend the settled pavers be further evaluated and corrected as needed. See pictures for further illustration and location.

Contact a qualified professional.

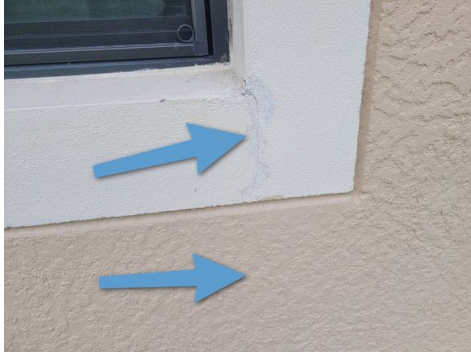
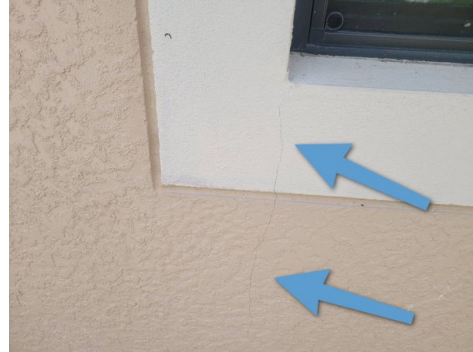
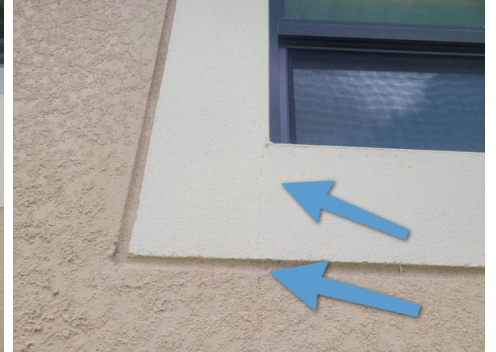
3.1.1 Wall Structure

CRACKS - STUCCO

There are some stucco cracks on the exterior of the home which are not uncommon. I recommend properly repairing and weatherproofing all stucco cracks to prevent potential moisture intrusion. This is a part of the normal maintenance for stucco siding. This is strictly a visual inspection and we are not able to identify any concealed conditions such as those behind stucco or behind drywall or baseboards. The pictures illustrated are a sample of some of the observations but may not indicate every crack.

Contact a handyman or DIY project

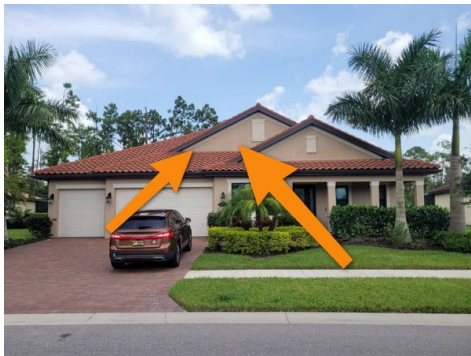
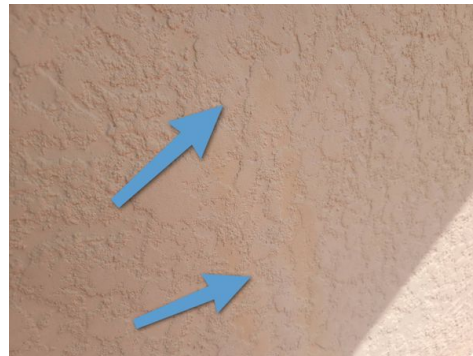
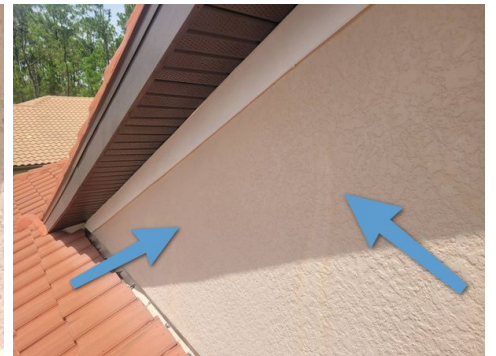
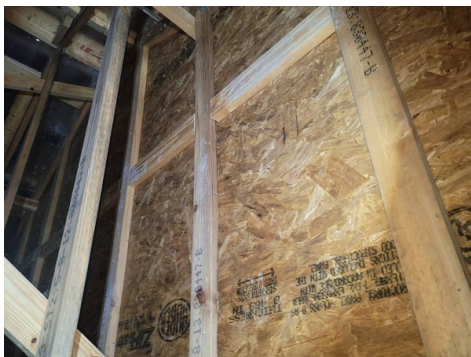
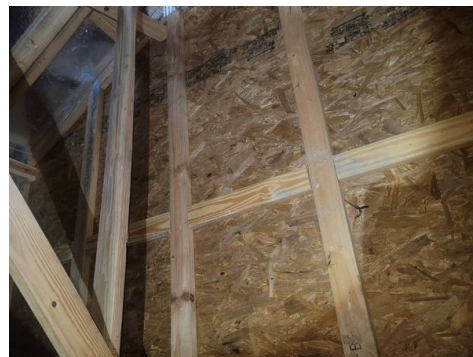
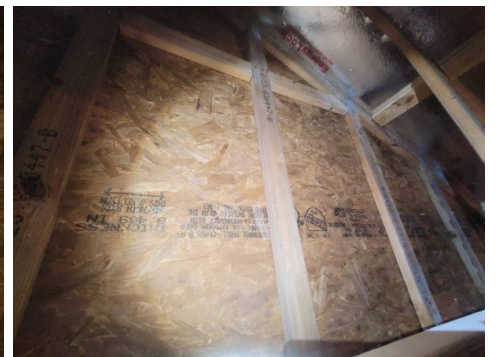
3.1.2 Wall Structure

WALL STAINING

There is staining visible on the exterior wall above the garage area. I also inspected the attic in the same area and there were no signs of water intrusion or damage visible at the time of the inspection. At this point, this is considered a cosmetic stain.

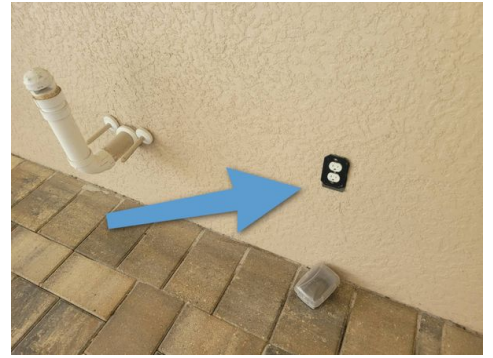
3.3.1 Exterior Electrical

OUTLET COVER- DAMAGED

There were damaged exterior outlet weather proof coverings. I recommend replacing these covers with properly rated exterior covers. See pictures below for the locations of the observations.

Lanai

Contact a qualified handyman.

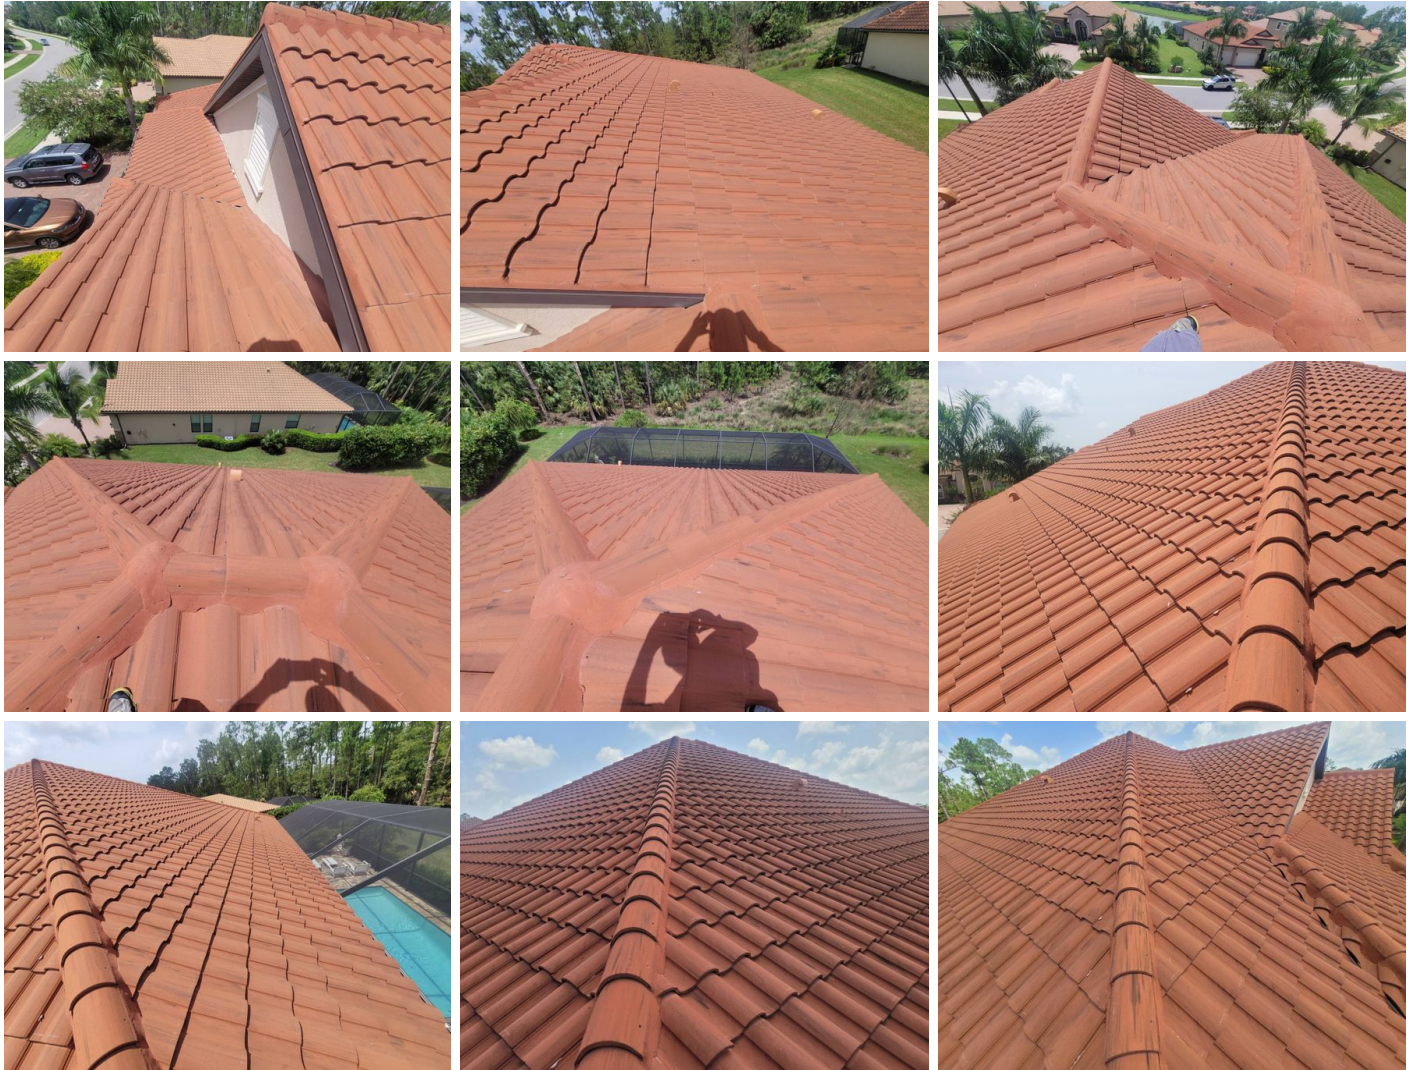
Tile roof pictures

Tile Roof Covering: Roof pictures

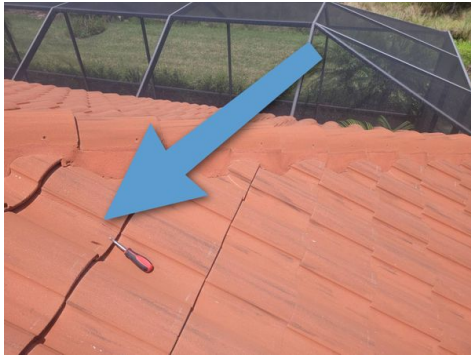
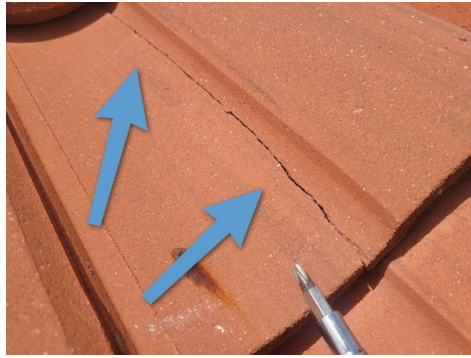
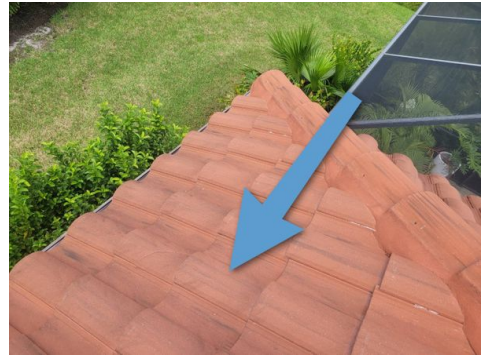
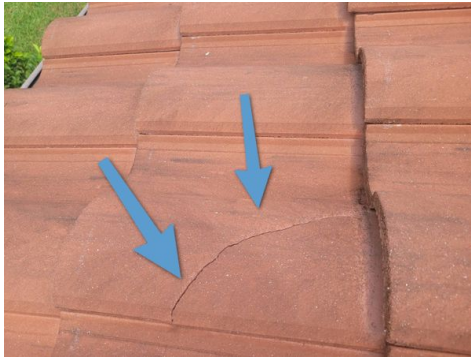
4.1.1 Tile Roof Covering

ROOF TILES- LOOSE/CRACKED/ BROKEN

We observed either loose, cracked or broken roofing tiles. Loose, cracked and broken tiles can often be a part of routine maintenance and is a common observation while inspecting tile roofs. See the enclosed pictures for further details on the conditions that we observed at the time of this inspection. We simply recommend that proper maintenance and repairs be performed by a qualified professional as needed.

Contact a qualified roofing professional.

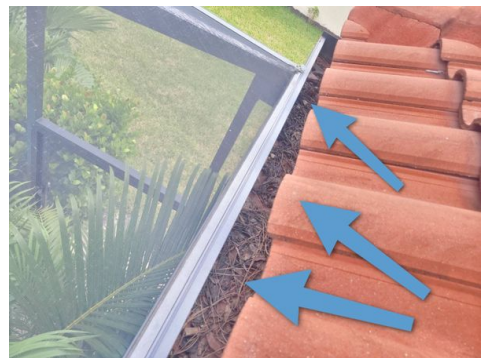
4.2.1 Roof Drainage Systems

GUTTER-DEBRIS

Some debris has accumulated in the gutters. I recommend cleaning to facilitate water flow.

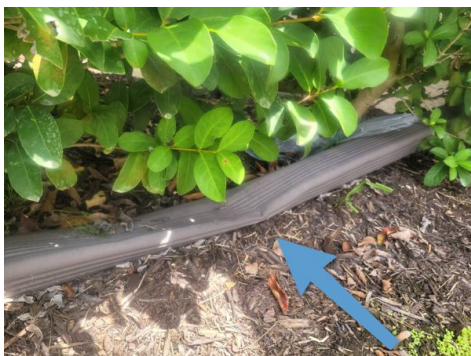
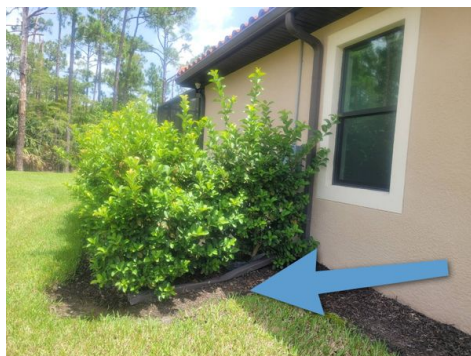
4.2.2 Roof Drainage Systems

GUTTER- DAMAGED DOWNSPOUT

The gutter/downspout was damaged. Water flow can be restricted making the downspout not function as intended. I recommend repair or replace as needed to obtain the intended flow of the gutter.

Exterior East

Contact a handyman or DIY project

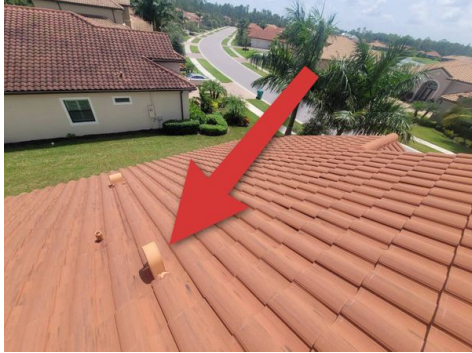
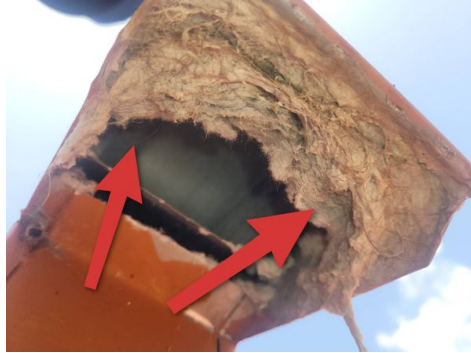
4.6.1 Roof Vents

DRYER VENT- OBSTRUCTION

Lint appeared to be obstructing the dryer vent as observed from the roof. I recommend it be cleaned and addressed for proper and safe ventilation.

Contact a qualified professional.

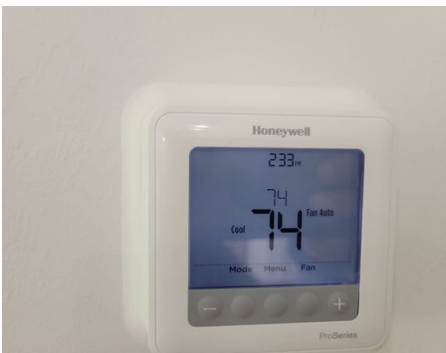
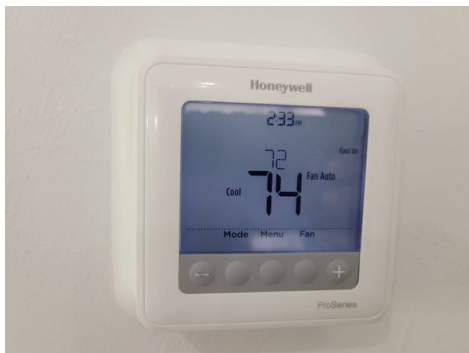
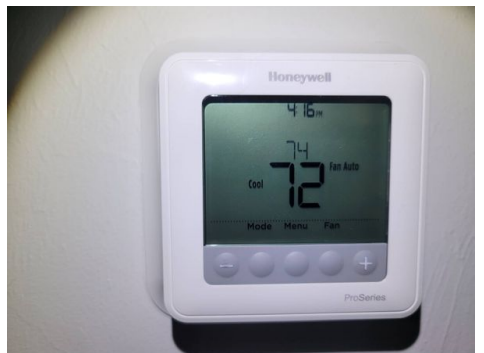
Thermostat Settings

These pictures show the thermostat settings before we started the home inspection and when we finished the inspection.

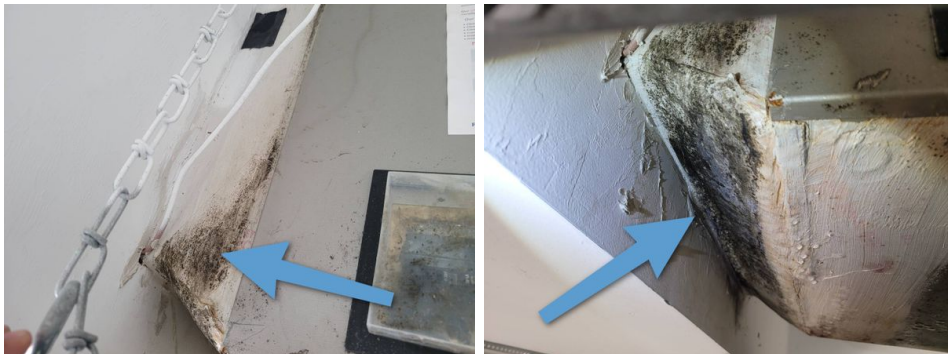
5.1.1 Heating & Cooling Equipment

MICROBIAL GROWTH AT PLENUM BOX

There was some visual microbial growth observed at the plenum box. This is not uncommon when cold air escapes into a warm garage which can cause condensation and create environment for this type of growth. I recommend the plenum box evaluated for any potential air leaks. I recommend the microbial growth be cleaned and addressed as needed.

Contact a qualified HVAC professional.

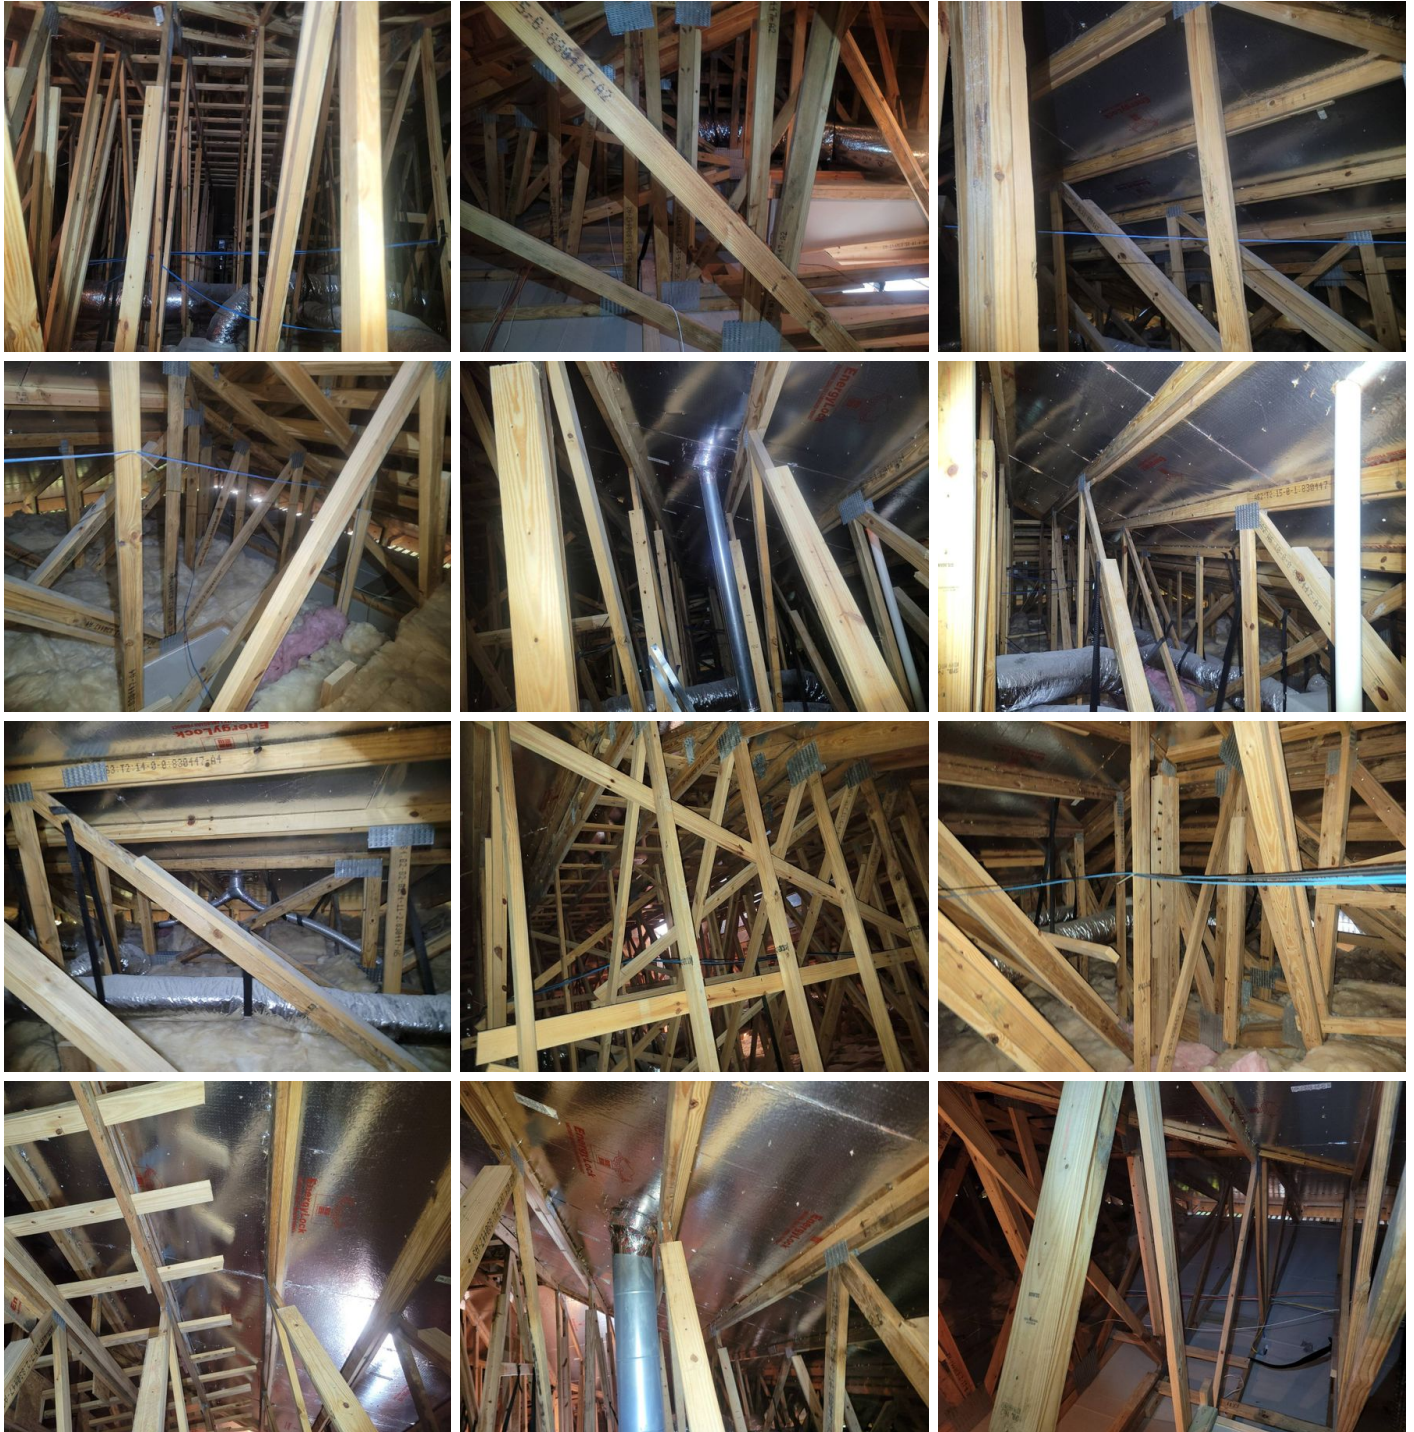
Trusses/ Sheathing: Attic Pictures

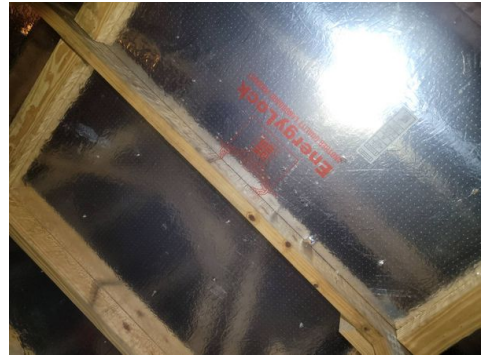
SHEATHING NOT VISIBLE- FOIL BARRIER

There was a radiant heat foil barrier installed in the attic to support energy efficiency. Due to the foil installation, a portion of the trusses and the sheathing were not visible at the time of this inspection.

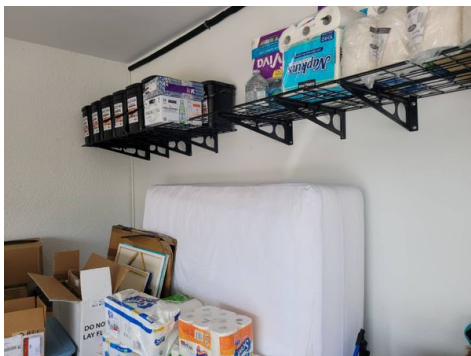
PERSONAL BELONGINGS

Personal belongings obstructed visibility of portions of the garage. Due to this, it is possible that Items or issues can later be identified that were not visible at the time of the inspection based on the conditions I was provided.

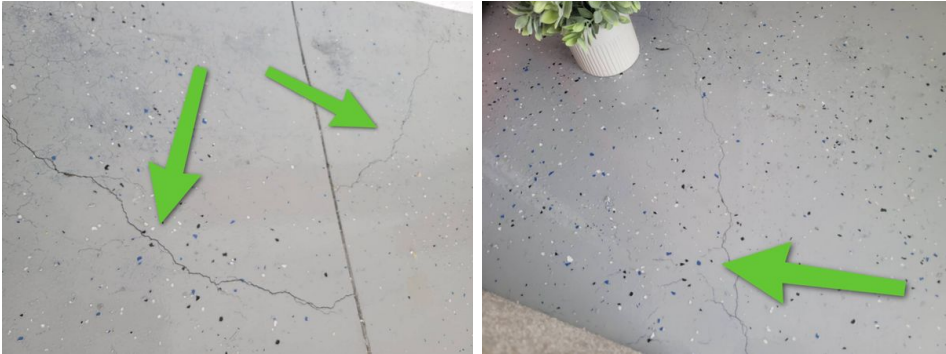
Floor, Walls and Ceilings

TYPICAL CRACKS

There was some typical cracking observed at the garage concrete floor. I simply recommend monitoring these cracks for movement

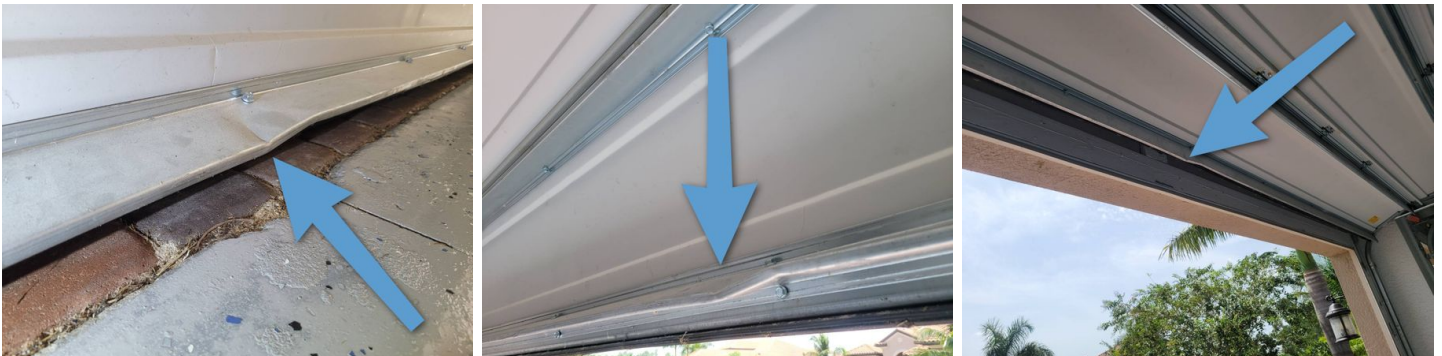
7.2.1 Overhead Garage Door

RAIL DAMAGE

One of the garage door rails is bent/damaged. I recommend further evaluation and repair or replace as needed.

Double door

Contact a qualified garage door contractor.

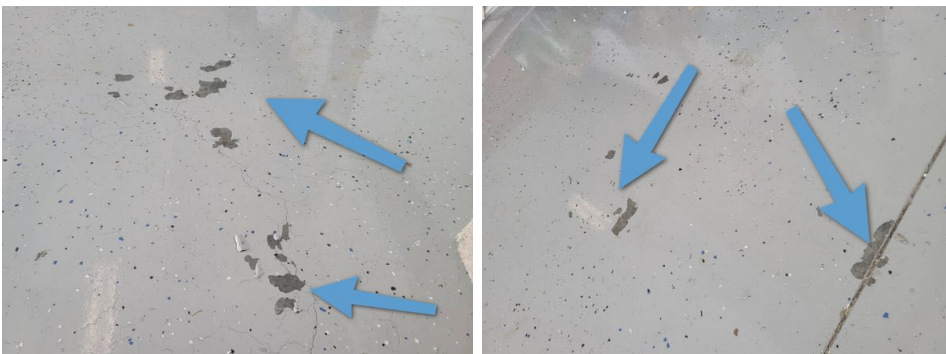
7.5.1 Floor, Walls and Ceilings

FLOOR PAINT PEELING OFF

Some of the garage floor paint is peeling off. I recommend repair as needed.

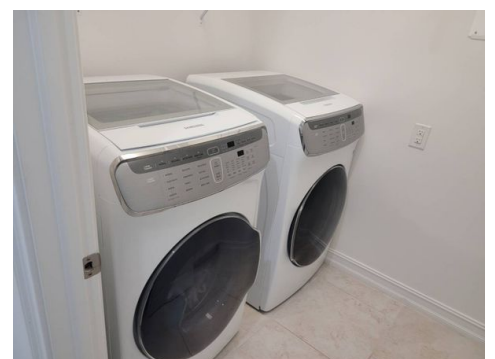
NOT INCLUDED/ WASHER AND DRYER

It was disclosed that the washer and dryer are not included in this sale. The appliances were not evaluated during this inspection.

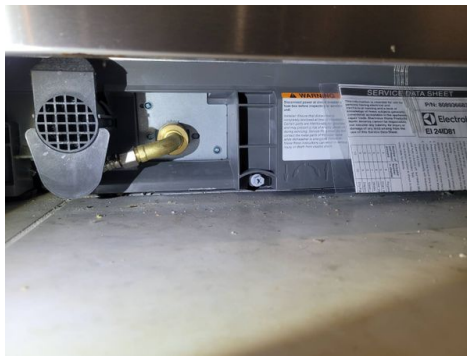
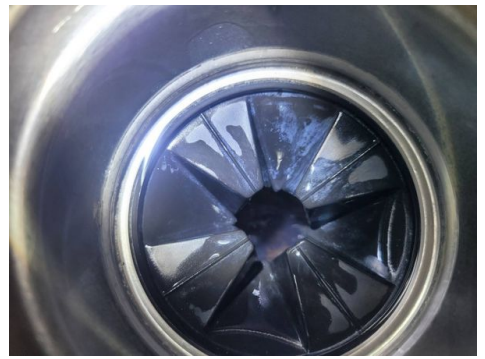
Dishwasher: Dishwasher Operated

The dishwasher operated a complete cycle. I removed the bottom plate and there were no visible signs of leaks at the time of the inspection.

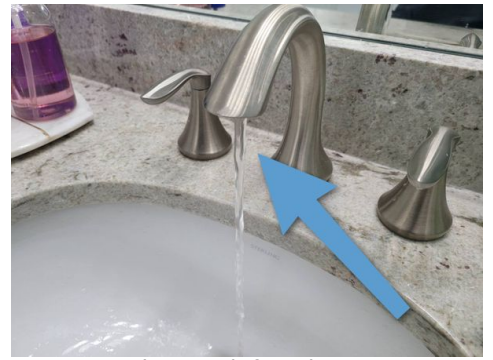
There was lower than usual water pressure observed at the bathroom sink pictured on this report. I simply recommend cleaning the aerator filter under the sink faucet and testing again. Address further if needed.

Master Bathroom left sink

Contact a handyman or DIY project

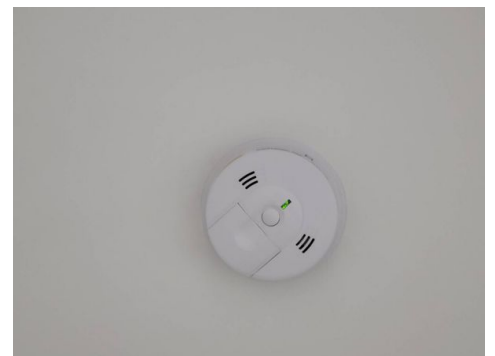
SMOKE DETECTOR BATTERIES

I always recommend replacing all batteries and testing the smoke detectors again before moving into the home. The smoke detectors operated when we tested, but they should be tested every month and should be tested again when you move into the home. I recommend changing the batteries as a safety measure.

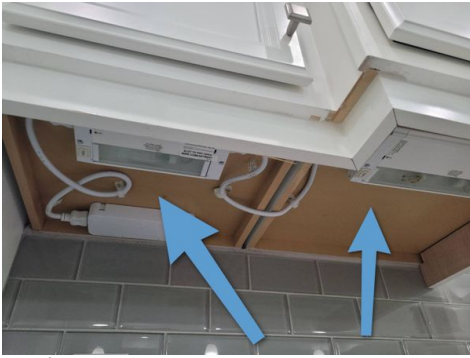
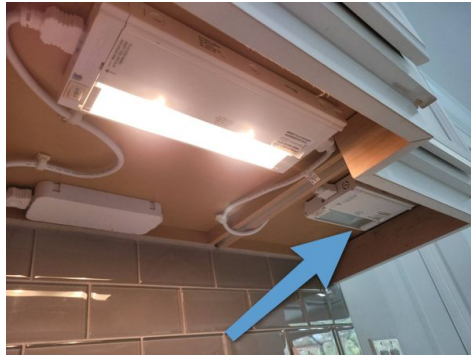
13.2.1 Fixtures, Receptacles, Switches

The light was not operating at the time of the inspection. I recommend replacing the light bulb and testing again for proper operation.

Kitchen

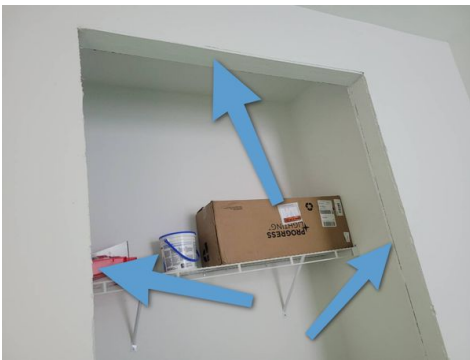
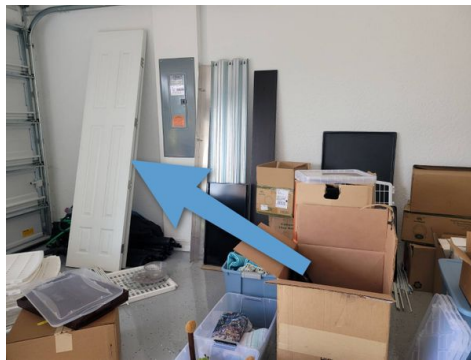
13.5.1 Doors

DOOR REMOVED

One of the interior doors and frame was removed. I recommend reinstalling the door and frame as needed.

Northeast Bedroom

Contact a qualified handyman.

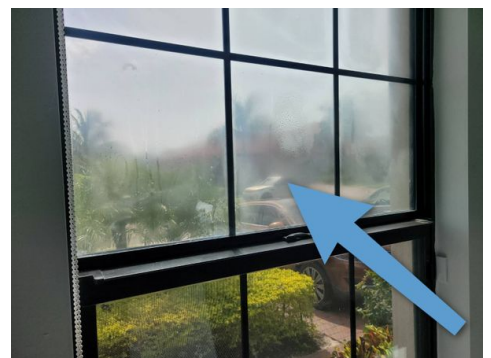
13.6.1 Windows

FAILED SEAL

Fog/ condensation was observed between the window panes, which indicates a possible failed seal. I recommend further evaluation and repair or replace as needed

Office/Den

Contact a qualified window repair/installation contractor.

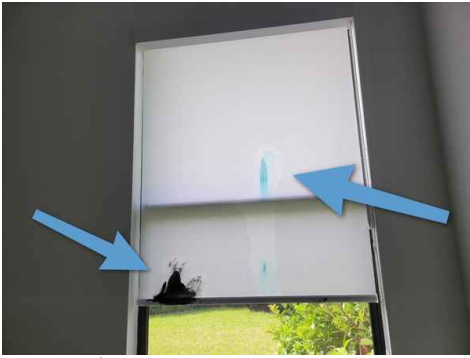
13.6.2 Windows

WINDOW TREATMENT/REPAIR

There was some damage observed to the window treatment shade. Repair/replace as needed.

East Bedroom

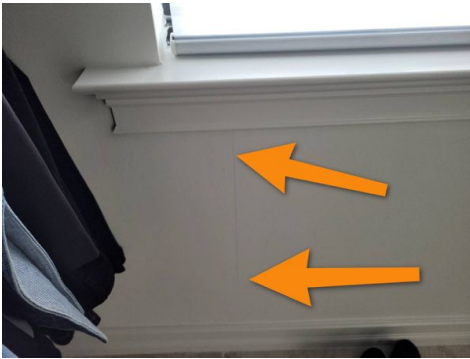
13.9.1 Walls & Ceilings

DRYWALL TAPE/JOINT CRACK

There are some drywall tape or joint cracks visible in the interior of the home. I recommend repairing as needed.

Master Bedroom closet

Contact a qualified drywall contractor.
